**PRIMECAB™**  
It's all about excellence

**Renufo®**  
Wires & Cables

# Instruction For Transportation, Handling, Storage Of The Drums And Laying Of The Cables

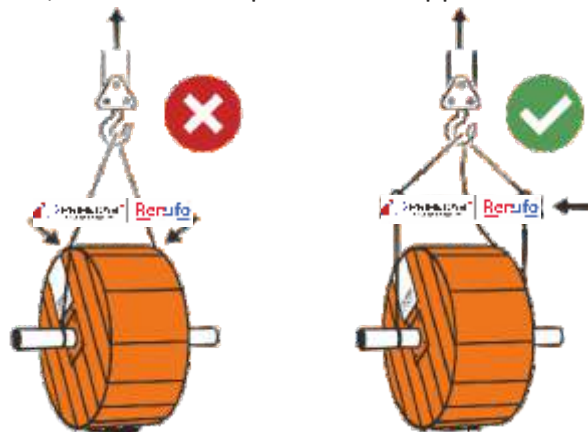
Drum flanges are marked to provide vital information to assist with the handling of the drums and the installation of the cable. This information includes drum weight, a mark on the flange indicating the end of the cable, and an arrow indicating the direction the drum is to be rolled during rolling or transportation.

The rolling of the drum in the direction of the arrow ensures that there is no tendency for the cable to loosen its wind on the drum. It should be noted that when pulling the cable off the drum and installing the cable, the arrow will point in the opposite direction to the rotation of the drum.

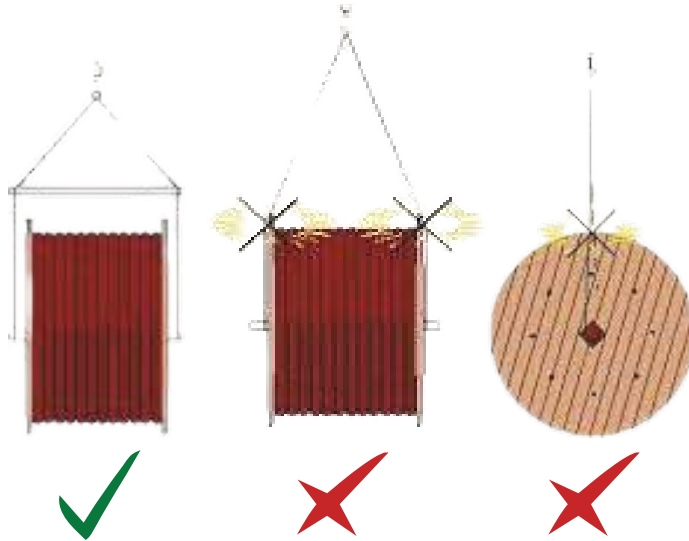
Some drums may be of sufficient length and weight to require cranes to load and unload from transport vehicles. In this case, it will be necessary to ensure that a spreader bar of sufficient length is used to ensure the lifting chains do not compress the drum flanges.

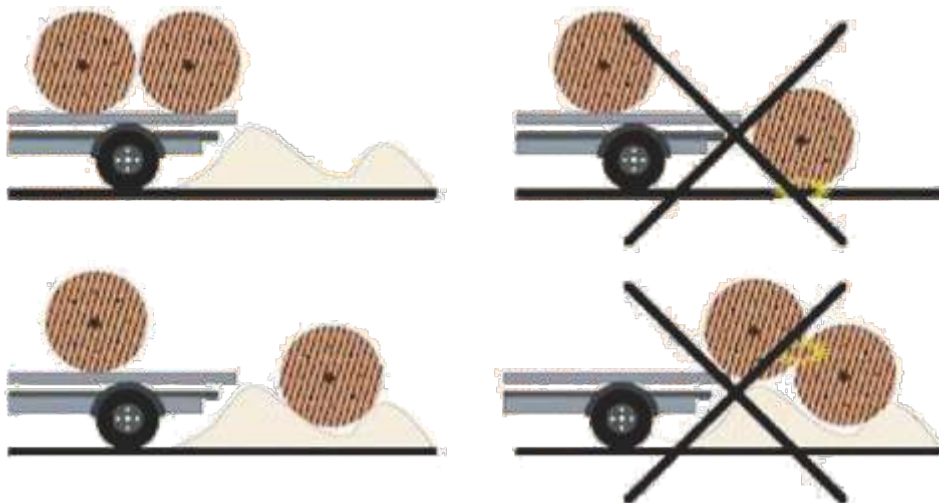
When forklift or crane is not available, a makeshift ramp with approximate inclination of 1:4 should be constructed. The cable drum should then be rolled over this ramp by means of ropes or winches. Additionally, a sand bed at the foot of the ramp can be build to brake the rolling cable drum.

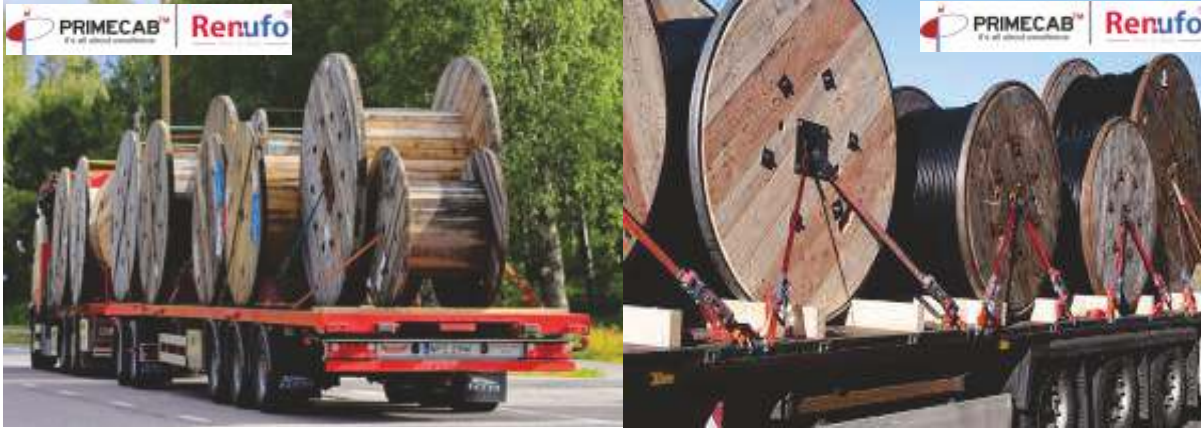
When the drums loaded on trucks are larger than 250cm, binding must be made with ropes crossing through the central hole and if necessary on the drum flanges.

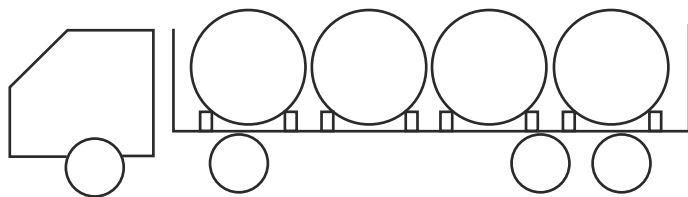
### Bore Perpendicular\* chocking

The Drums are places parallel to the lorry axis

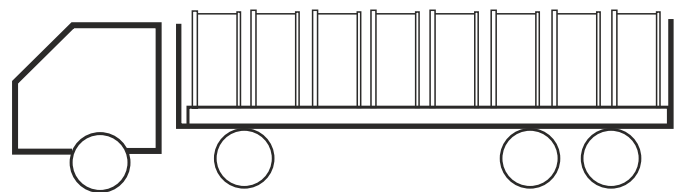
### \*Bore parallel\* chocking

The drums are places perpendicular to the lorry axis

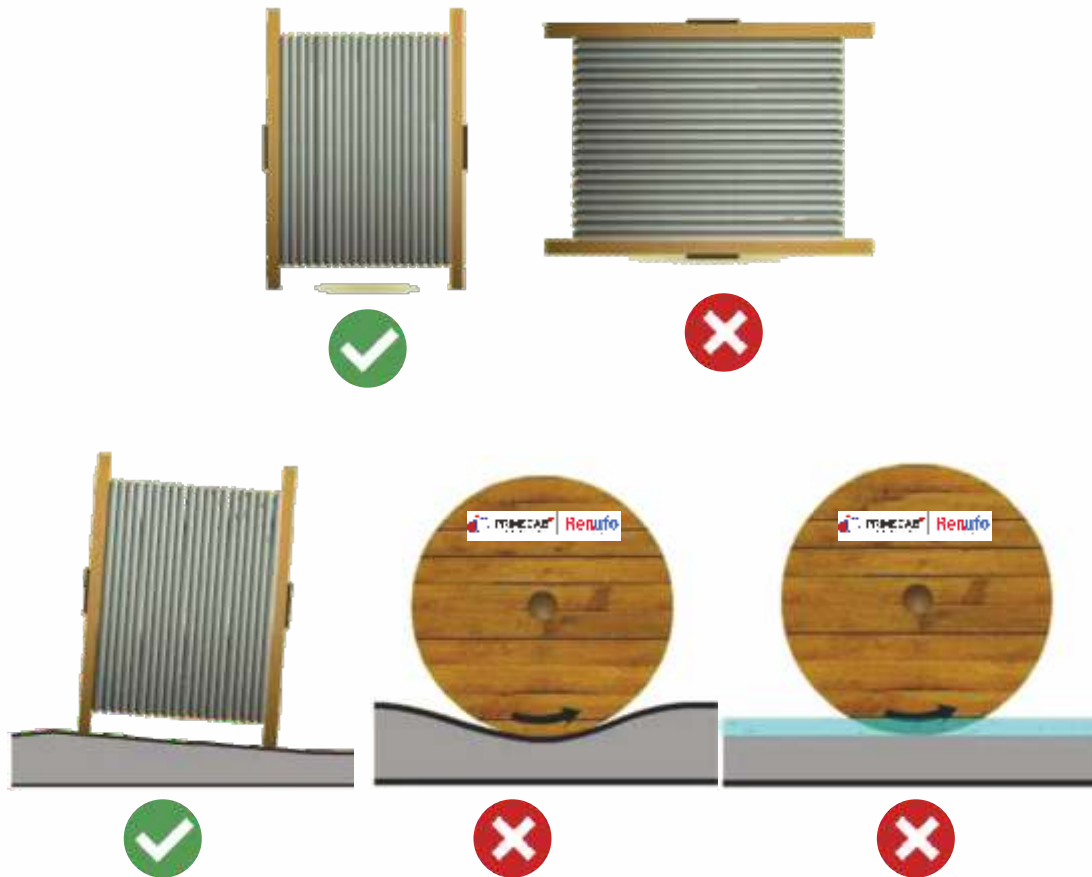
Drums should be stored on a level and firm surface (e.g. timber baulks, firm gravel, or concrete), on the flange edges (not with the flange flat on the ground), such that they will not be standing in water or in continually damp conditions, and restricted from rolling.

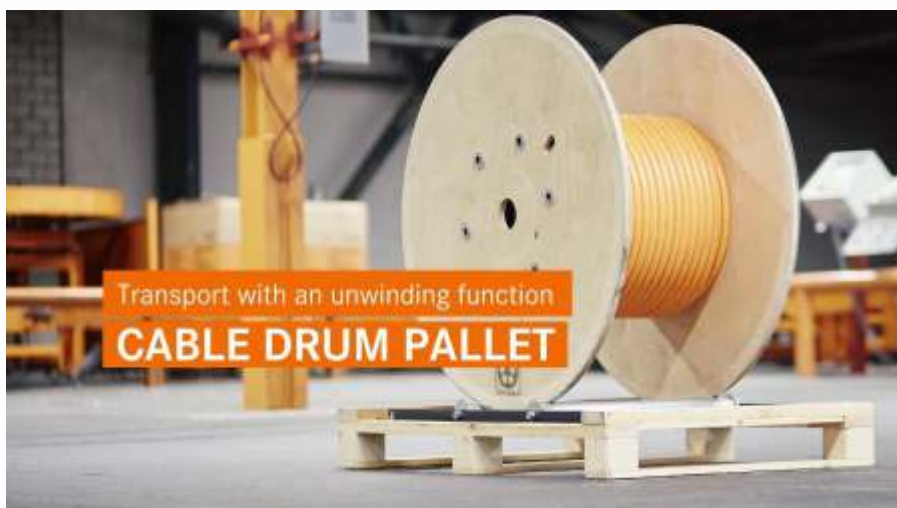
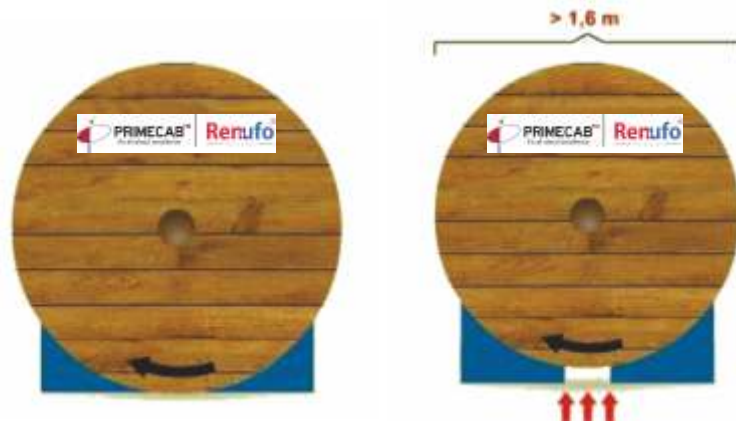
Wedges must be used to retain drums: Wedges must be positioned at flange edges and not between flanges. The use of stones are not recommended.

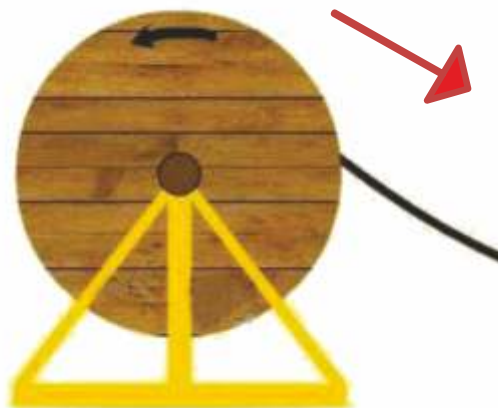
## Cable end caps and pulling eyes

Cable ends will be protected by end caps or by pulling eyes. For longer lengths of cable(perhaps over 800 m) or for large conductor sizes (over 630 mm), PRIMECAB | RENUFO recommends the use of pulling eyes fixed to the main conductors of the cable. Pulling long and heavy cables by pulling socks can lead to cable or

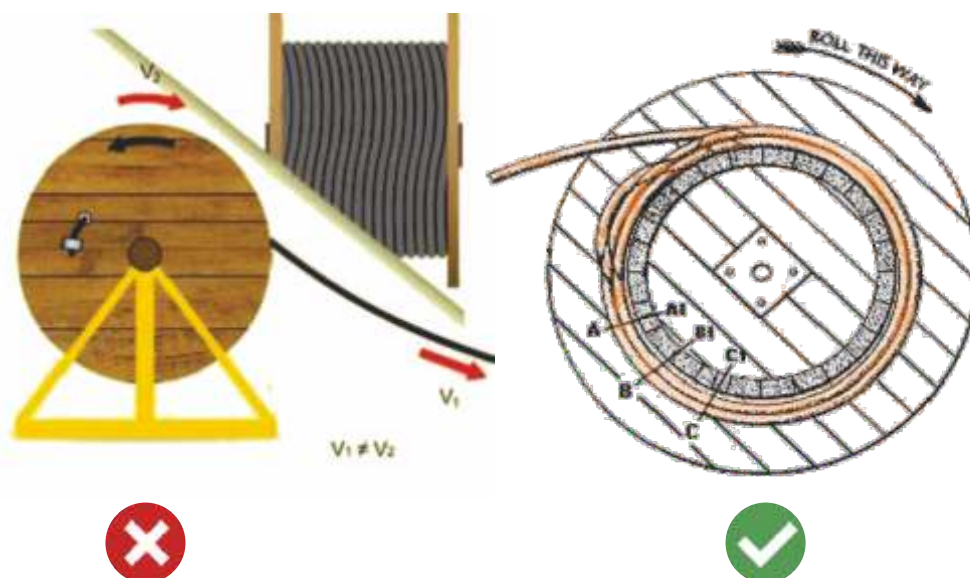
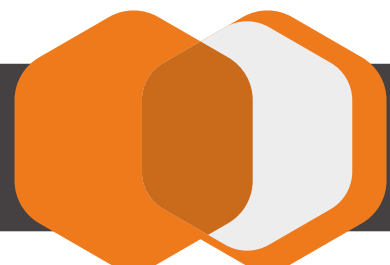
*Fixed Cable End – Creepage occurs*

*Free Cable End – Extra length is formed outside*

The inside end of the cable has a tendency to creep through the hole in the flange when the drum is revolved in the opposite direction to that originally employed when winding the cable onto it. This tendency cannot be prevented. The amount of creepage depends on the length of the cable on the drum, the size of the cable and the number of times the drum is revolved. The accumulated slack due to unwinding long lengths of cable may amount to several metres. It can become extensive when the timber drums bolts have loosened or the timber has aged and shrinkage has taken place.

Cable-Make or Cable Creepage is sometimes alleviated by pulling the cable off the drum from the bottom rather than the top of the drum and so the reeling is in the same direction of the arrow painted on the flange of the drum. In this case, it may occur that the cable inner end, intentionally left out for testing, will in fact withdraw into the drum and will be "lost" unless it is fixed firmly to the drum flange. If the end is allowed to move inside the drum, it is possible that the friction and tight space will exert pressure on any cable end cap and cause it to be pulled off.

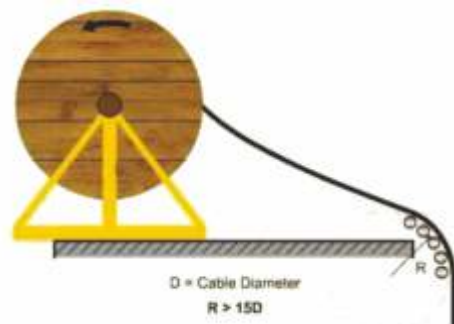
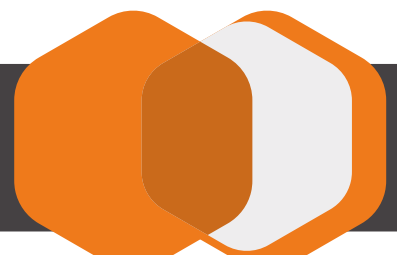
### b) Minimum bending radius (during installation)

Ducting at cable bends must be selected so the curvature is not below the minimum bending radius during installation. When using rollers at cable changes in direction, it is recommended a number of rollers are used forming a radius that is larger than the minimum bending radius.

Special care needs to be taken at duct entry points, where sharp bending of the cable can take place, when a bend is close to the duct entry. It is necessary that supports are used so that the cable is directed into the duct in parallel to the duct direction and that any bending radius is greater than the minimum bending radius during installation.
